The Road Inventory of Greers Ferry National Fish Hatchery Heber Springs, AR

Prepared By: Federal Highway Administration Central Federal Lands Highway Division September, 2011

Greers Ferry National Wildlife Refuge - 43235

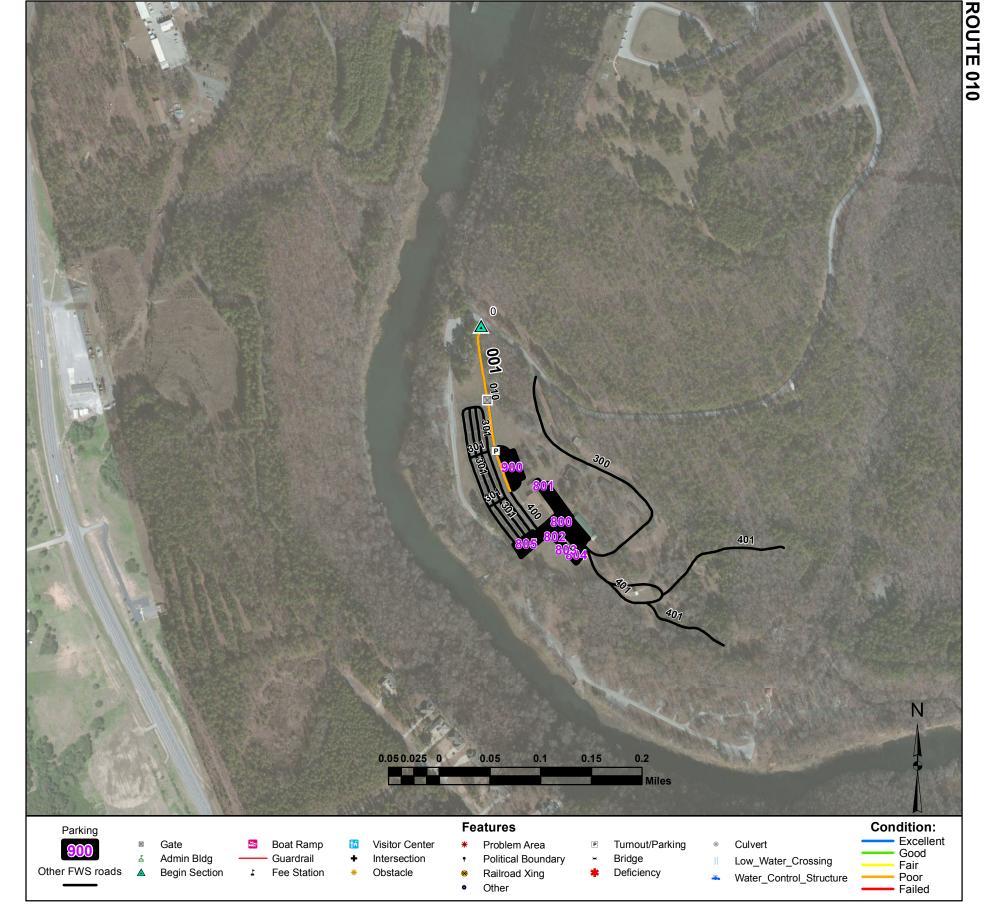
Hatchery Entrance Road

From Hatchery Road to Office Access Road (Route 400)

Asset Number	10017180
Section Number	001
Section Length (miles)	0.16
Inspection Date	05-26-2011
Surface Type	Asphalt
Number of Lanes	2
Roadway Width (feet)	20
ondition	Poor
Remaining Service Life (years)	6
stimated Cost to Repair	\$90,800
Current Replacement Value	\$184,400

Mile Post	Features	Mile Post	Features	Mile Post	Features	Mile Post	Features
						001-0.0 001-0.07 001-0.12	Begin Section Gate Turnout/Parking

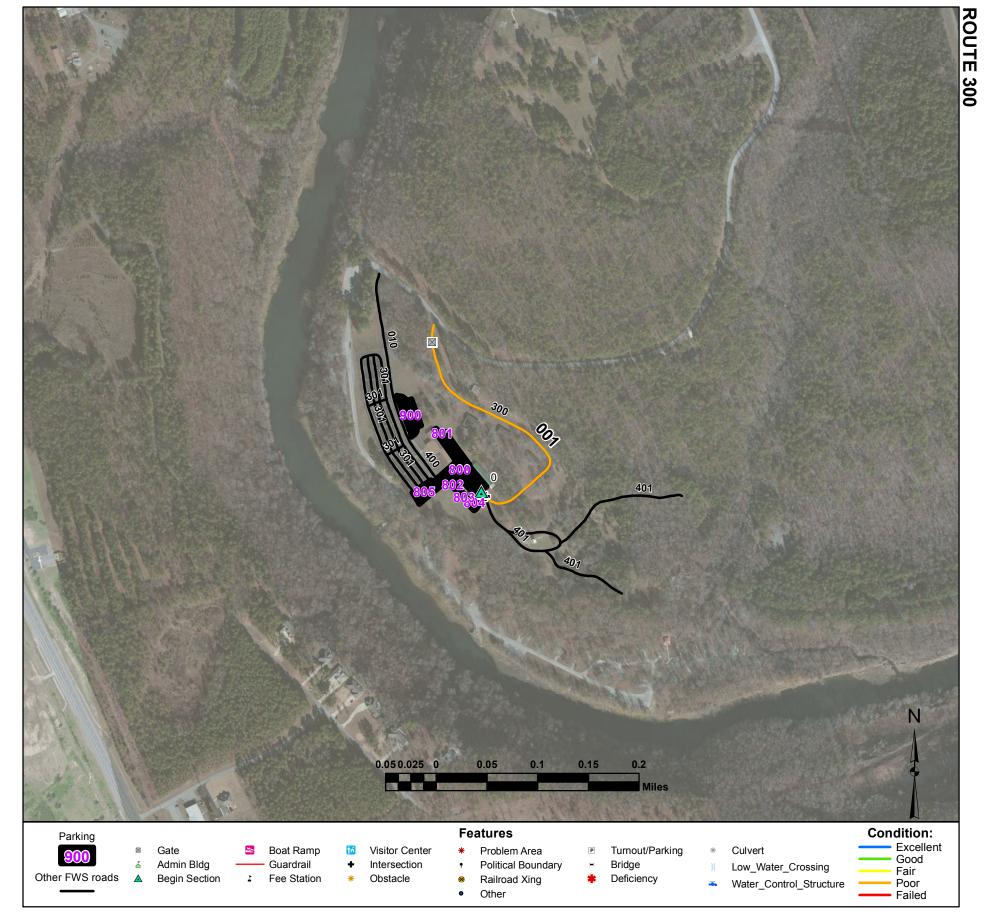
Residence Road

From Shop Parking (Route 800) to Hatchery Road

Asset Number Section Number Section Length (miles) Inspection Date	10017176 001 0.27 05-26-2011	
Surface Type Number of Lanes Roadway Width (feet)	Asphalt 2 16	
Condition Remaining Service Life (years) Estimated Cost to Repair Current Replacement Value	Poor 6 \$153,300 \$311,200

Features	Mile Post	Features	Mile Post	Features	Mile Post	Features	Mile Post
Begin Section Intersection Gate	001-0.0 001-0.01 001-0.25

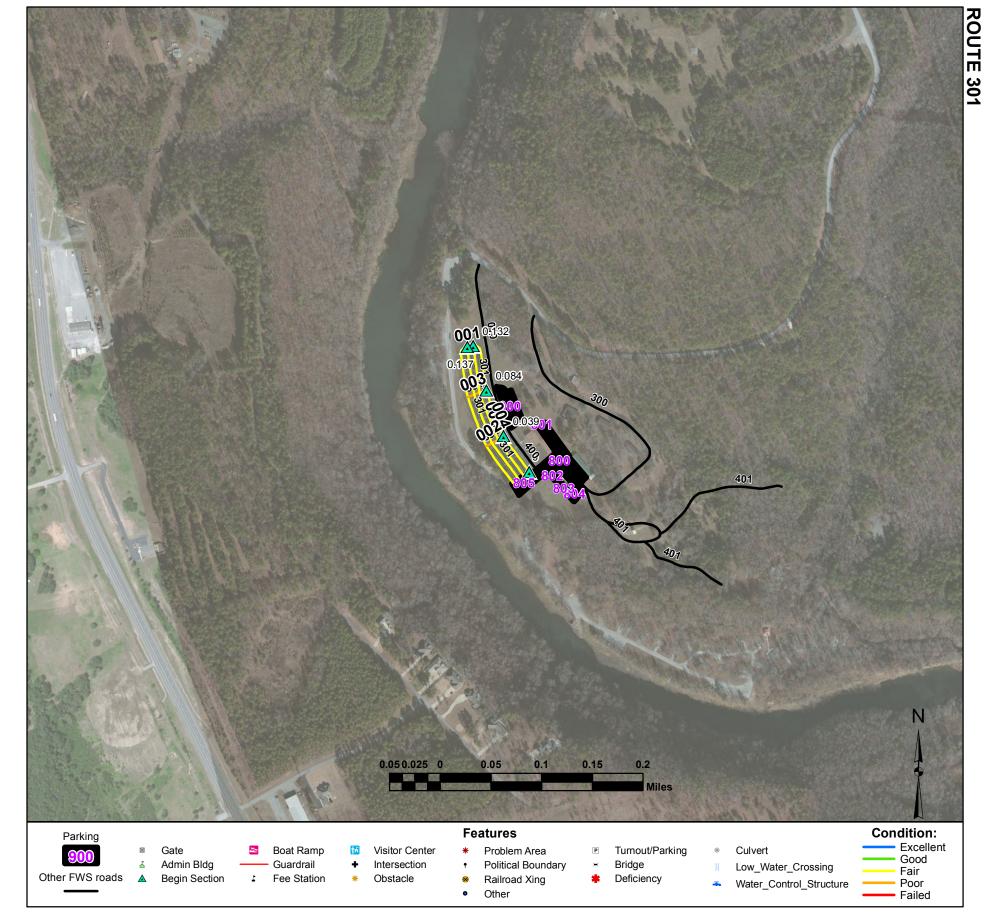
Raceway Road

From Raceway Parking (Route 805) to Raceway Parking (Route 805)

Asset Number Section Number Section Length (miles) Inspection Date	10036194	10036194	10036194	10036194	10036194
	001	002	003	004	005
	0.28	0.02	0.02	0.13	0.13
	05-26-2011	05-26-2011	05-26-2011	05-26-2011	05-26-2011
Surface Type Number of Lanes Roadway Width (feet)	Asphalt	Asphalt	Asphalt	Asphalt	Asphalt
	2	2	2	1	1
	16	42	42	14	14
Condition Remaining Service Life (years) Estimated Cost to Repair Current Replacement Value	Fair	Poor	Poor	Fair	Fair
	8	6	6	8	8
	\$29,100	\$11,400	\$11,400	\$13,500	\$13,500
	\$322,700	\$23,000	\$23,000	\$149,800	\$149,800

Features	Mile Post	Features	Mile Post	Features	Mile Post	Features	Mile Post
Begin Section	001-0.0						
Begin Section Begin Section	002-0.04 003-0.08						
Begin Section	004-0.13						
Begin Section	005-0.14

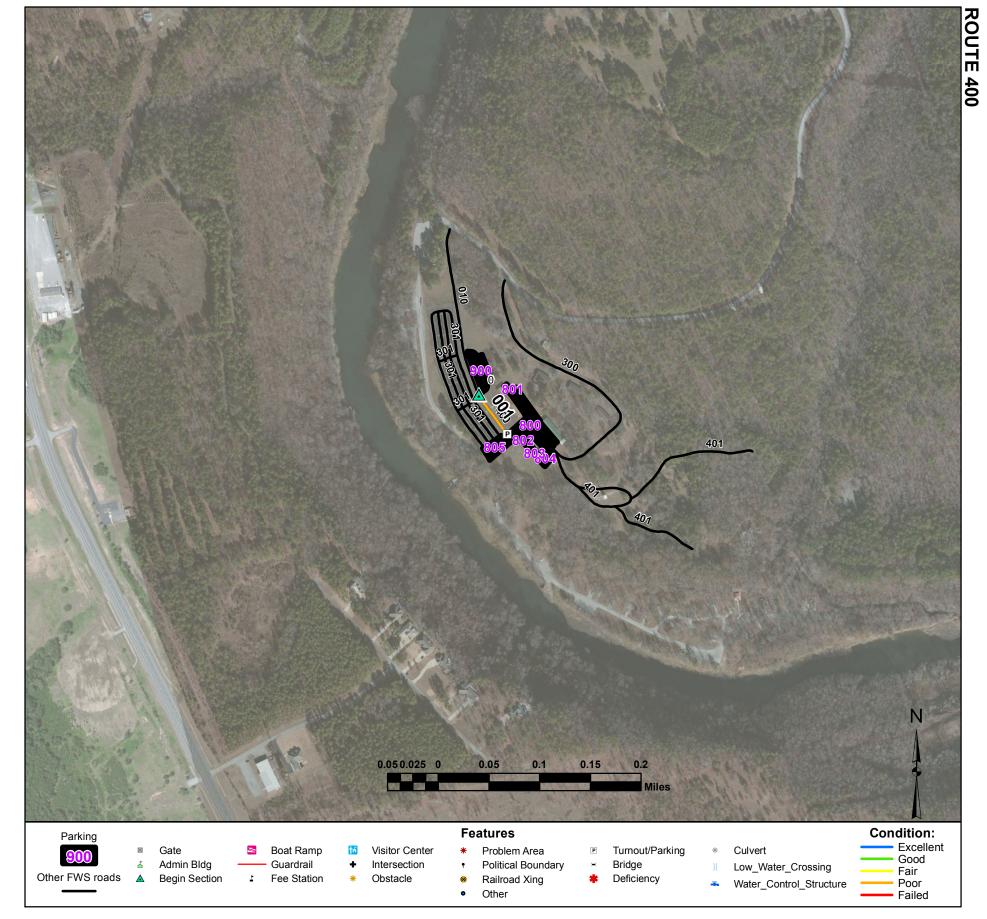
Office Access Road

From Hatchery Entrance Road (Route 010) to Shop Parking (Route 800)

Asset Number	10036194		
Section Number	001		
Section Length (miles)	0.05		
Inspection Date	05-26-2011		
Surface Type	Asphalt		
Number of Lanes	2		
Roadway Width (feet)	20		
Condition	Poor		
Remaining Service Life (years)	6		
Estimated Cost to Repair	\$28,400		
Current Replacement Value	\$57,600

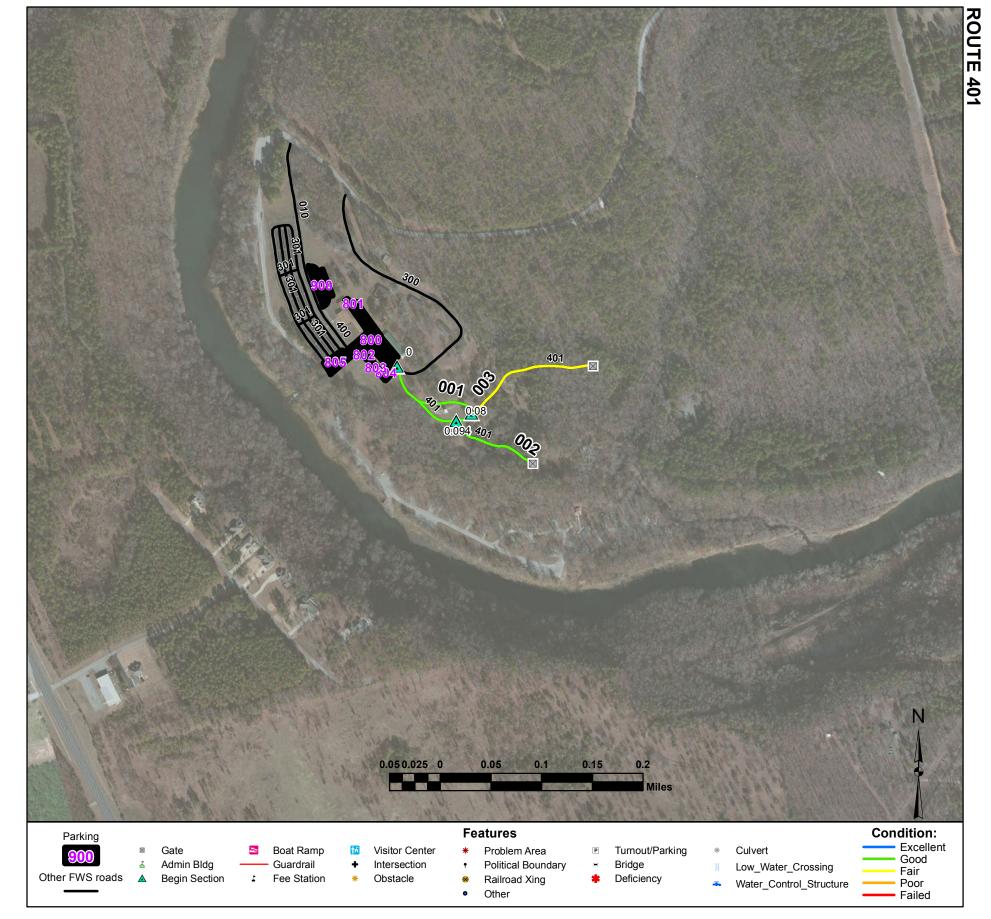
Feed Bin Road

From Residence Road (Route 300) to hatchery boundary

Asset Number	10036194	10036194	10036194	
Section Number	001	002	003	
Section Length (miles)	0.15	0.08	0.13	
Inspection Date	05-26-2011	05-26-2011	05-26-2011	
Surface Type	Gravel	Primitive	Native	
Number of Lanes	1	1	1	
Roadway Width (feet)	12	12	10	
Condition	Good	Good	Fair	
Remaining Service Life (years)	7	7	3	
Estimated Cost to Repair	\$200	\$0	\$300	
Current Replacement Value	\$99,600	\$0	\$44,700

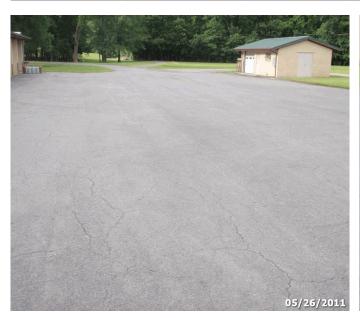
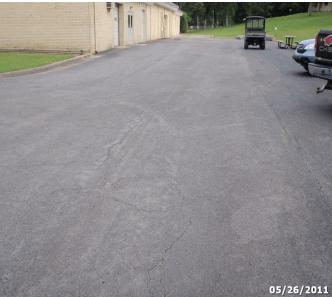
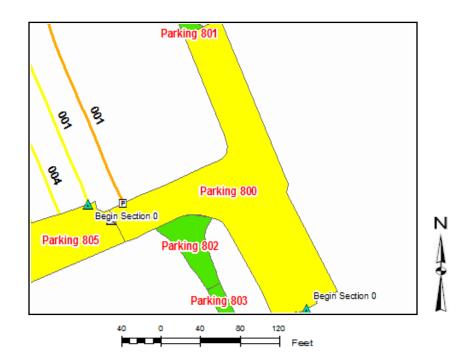
800: Shop Parking

A 4	D-4-	0	A		
Asset Number	Date Visited	Surface Type	Area (Sg Ft)	Condition	Cost to Improve
10036194	05/26/2011	Asphalt	25,205	Fair	20,800

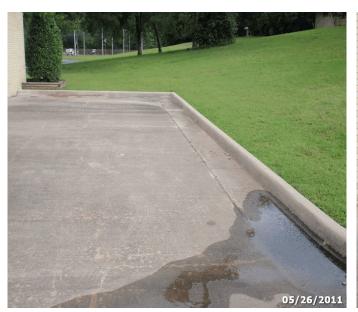
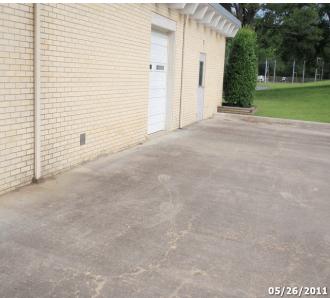
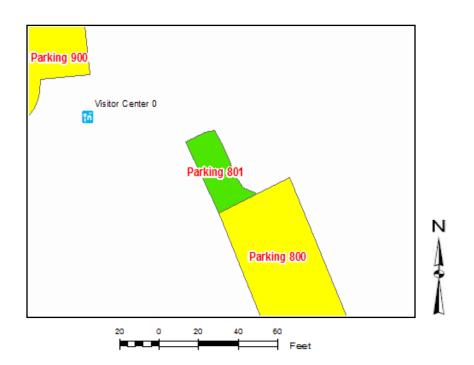
801: Hatchery Building Rear Parking

Asset Number	Date Visited	Surface Type	Area (Sq Ft)	Condition	Cost to
10036194	05/26/2011	Concrete	757	Good	100

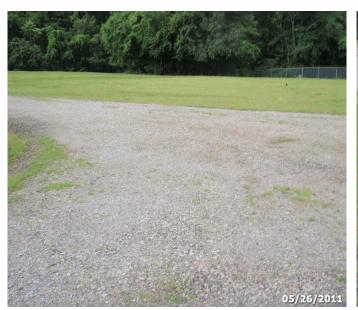
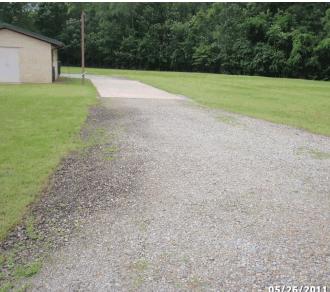
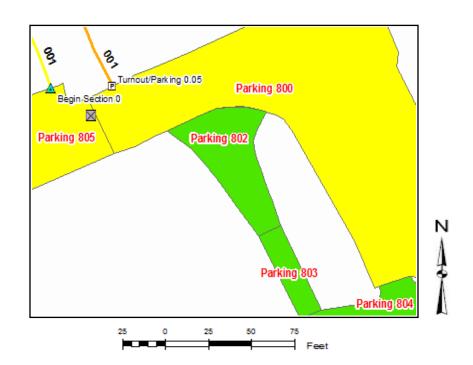
802: Decontamination A Parking

Asset Number	Date Visited	Surface Type	Area (Sq Ft)	Condition	Cost to
	10036194	05/26/2011	Gravel	2,621	Good	400

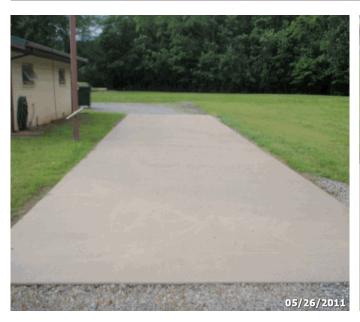
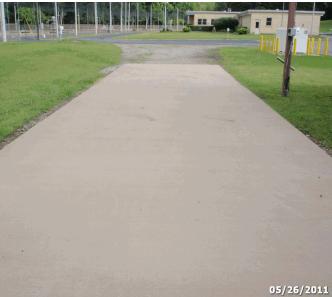
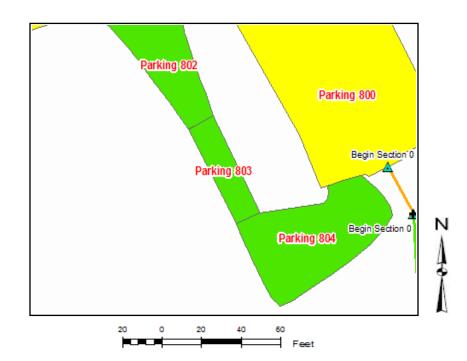
803: Decontamination B parking

Asset Number	Date Visited	Surface Type	Area (Sq Ft)	Condition	Cost to Improve
10036194	05/26/2011	Concrete	876	Good	100

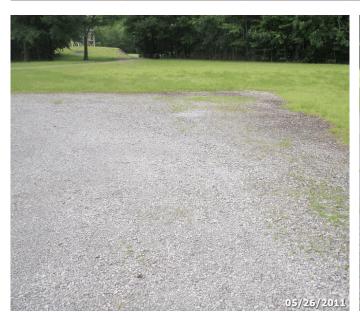
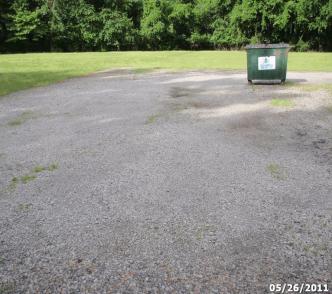
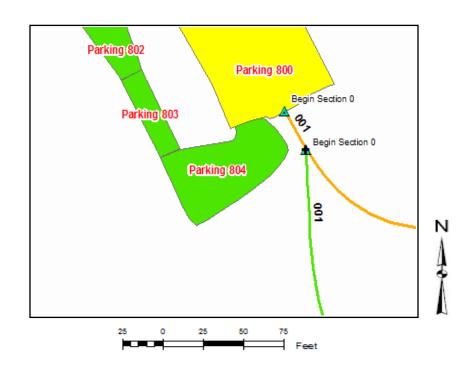
804: Decontamination C parking

Asset	Date	Surface	Area	0	Cost to
Number	Visited	Туре	(Sq Ft)	Condition	Improve
10036194	05/26/2011	Gravel	3,263	Good	500

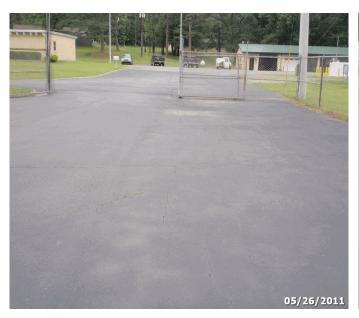
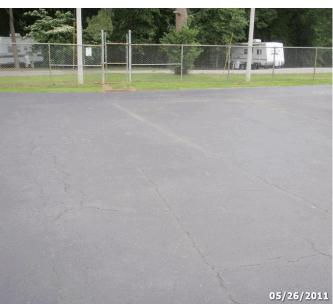
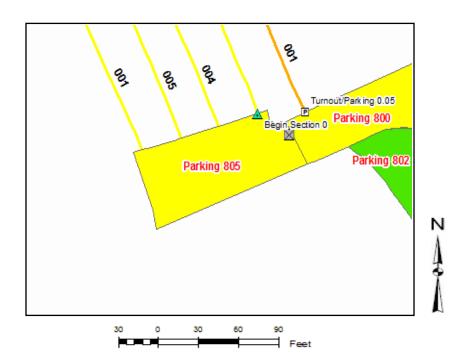
805: Raceway Parking

Asset Number	Date Visited	Surface Type	Area (Sq Ft)	Condition	Cost to
10036194	05/26/2011	Asphalt	7,270	Fair	6,000

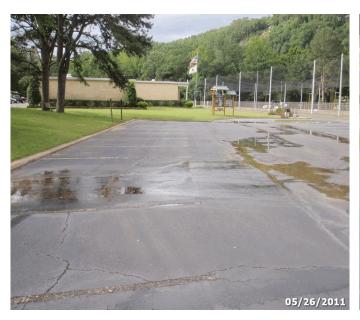
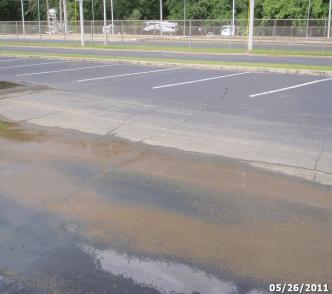
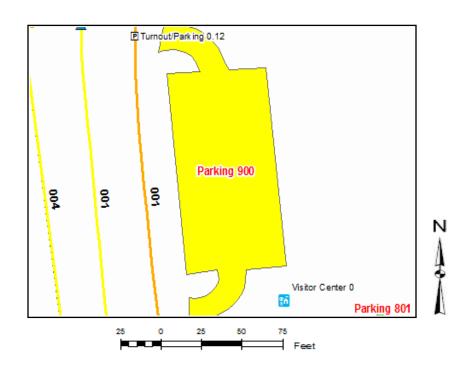
900: Visitor Center Parking Area

Asset	Date	Surface	Area		Cost to
Number	Visited	Туре	(Sq Ft)	Condition	Improve
10017180	05/26/2011	Asphalt	10,460	Fair	8,600
